**R and CENTER
LABORATORY
TECHNICAL REPORT**

IMPROVING THE HIGH TEMPERATURE
CREEP AND RUPTURE RESISTANCE
OF OXIDE-DISPERSION-STRENGTHENED ALLOYS

Department of the Army Project No. DAAE07-80-C-9091

by Case Western Reserve University
Cleveland, Ohio

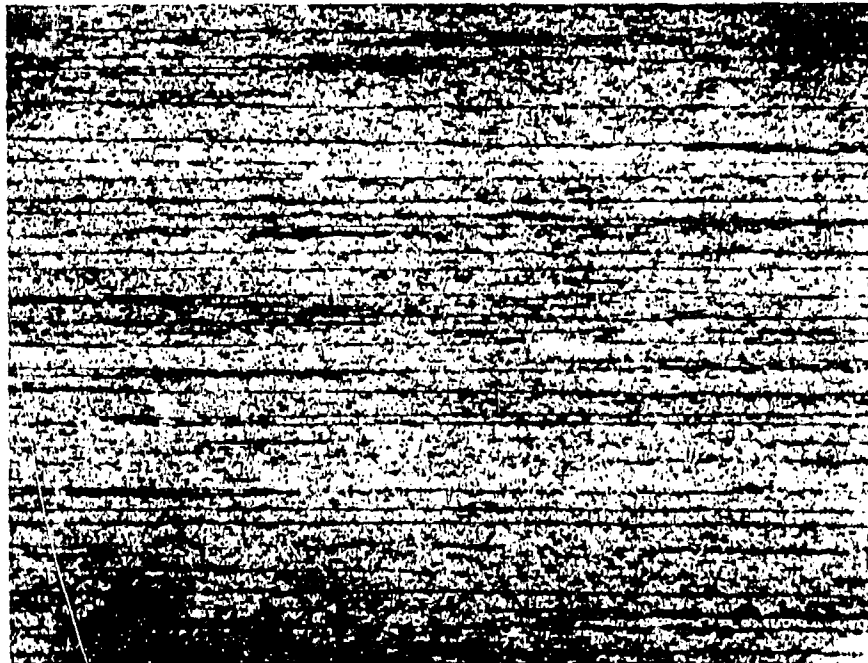
Figure 20: Optical Photomicrographs of MA 754 Alloy Cold Rolled to 70% Reduction in Thickness. Specimen Etched; 100 X Magnification.

a. Longitudinal Section

b. Transverse Section

Cold rolling of the MA 754 blank greatly improved the aspect ratio of the long grains, and produced flattening in the short transverse direction. Figure 20 shows the longitudinal and transverse microstructures of the rolled material.

As a result of cold rolling the as-received alloy to 70% reduction in thickness, it became necessary to attempt the development of an appropriate strain energy relaxation treatment in order to stabilize the improved grain morphology shown in Figure 20.

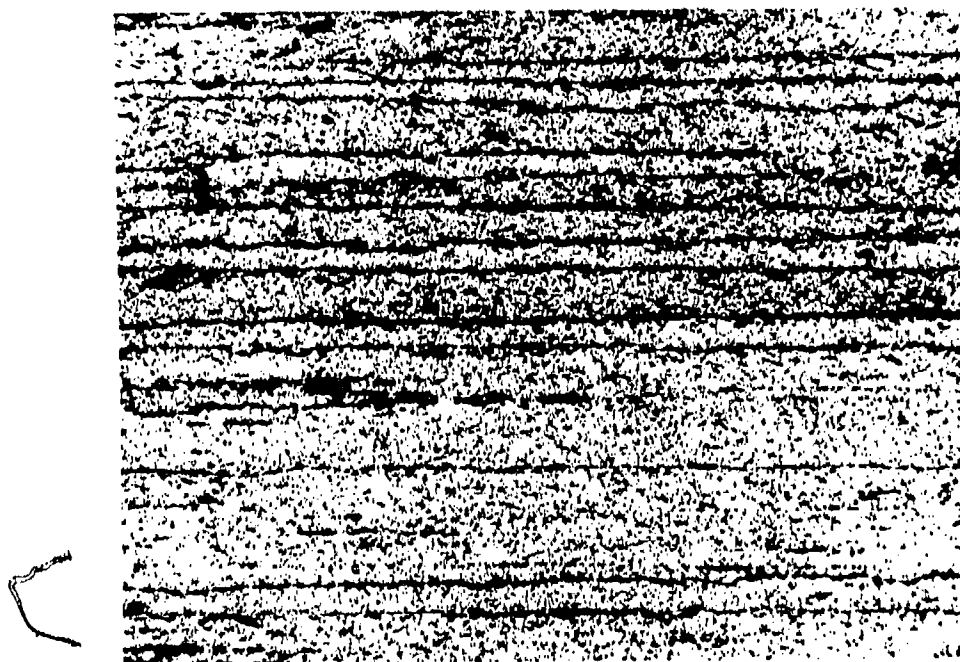
Figure 24: Optical Photomicrographs of a Cold Rolled Plate of MA 754;
35% Reduction in Thickness.
Specimen Etched; 60 X Magnification

a. Longitudinal Section

b. Transverse Section

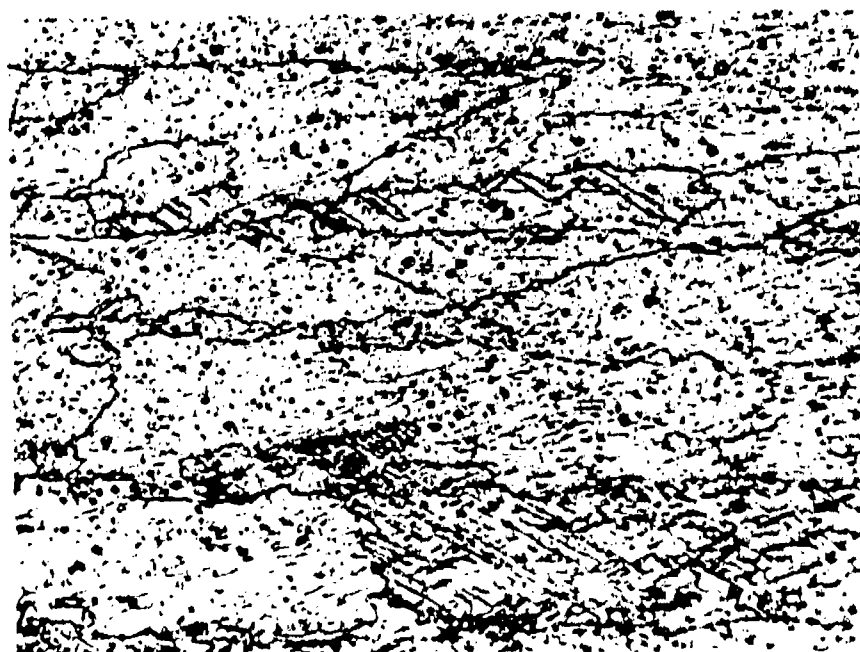
Figure 27: Optical Photomicrograph of a Longitudinal Section of MA 754 Cold Rolled to 35% Reduction in Thickness and Annealed at 2400°F (1315°C) for 4 hours. Specimen Etched; 420 X Magnification.

Figure 27 is an optical photomicrograph revealing a microstructure common to all three samples. The following conclusions seem warranted:

1) The intermediate anneals apparently have no effect on structure, since as-rolled samples produced a similar microstructure upon annealing at 2400°F.

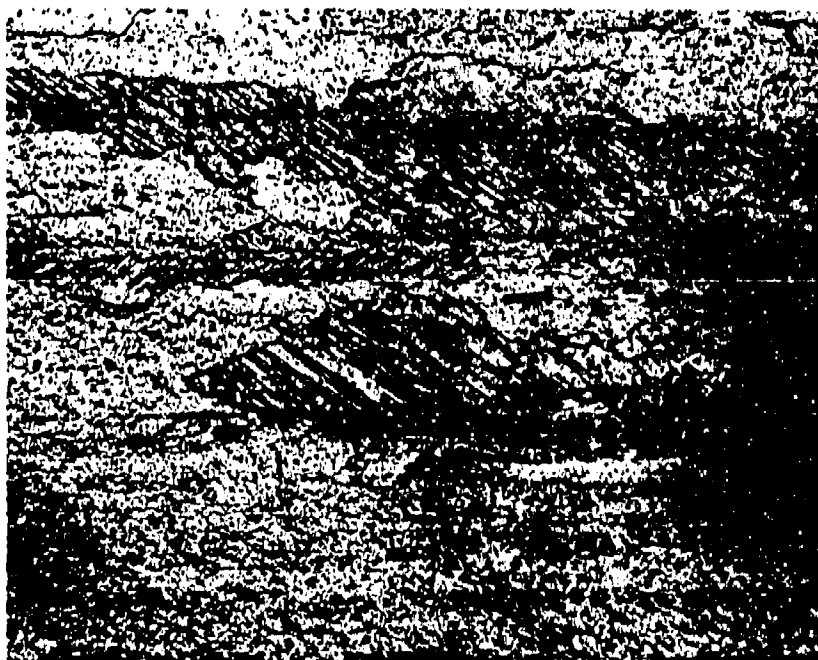
Figure 31: Optical Photomicrograph of a Longitudinal Section of MA 754 Cold Rolled 20% Reduction in Thickness, and Annealed Four Hours at 2400°F (1315°C). Specimen Etched 160 X Magnification. Note that the microstructure is similar to that found in specimens cold rolled 35% and annealed at 2400°F (1315°C).

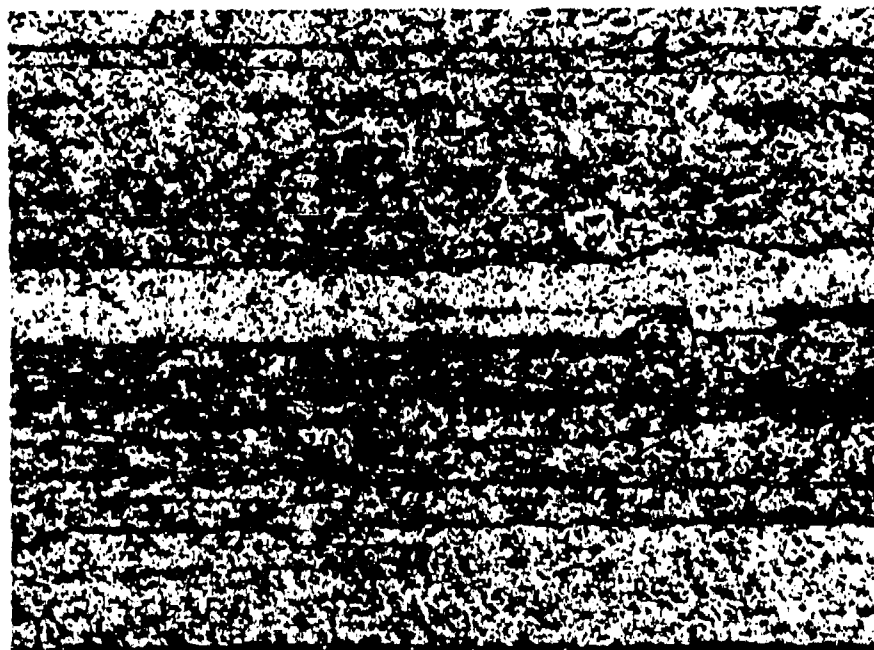
Figure 34: Optical Photomicrograph of a Longitudinal Section of
MA 754, As-Received and Annealed Four Hours at 2400°F
(1315°C).
Etched Condition 200 X Magnification

- 2) The hardness of MA 754 cold rolled and annealed according to the revised schedule does not appear to vary significantly with increasing reduction. This observation is consistent with the structures observed in Figures 34 through 37.

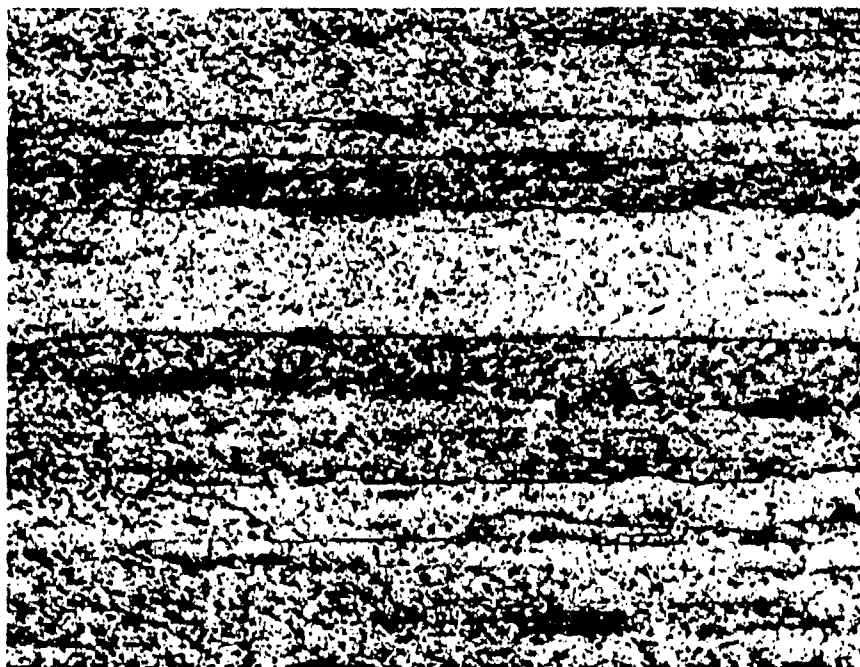
Figure 35: Optical Photomicrograph of a Longitudinal Section of
MA 754 Cold Rolled 15% Reduction in Thickness and
Annealed According to the Revised, Stepwise Schedule
of Cold Rolling and Annealing.
Etched Condition 100 X Magnification
